# Manhole Inspection Summary

Manhole # S33OO1010MH

**Location** Address: **MILLBROOKE RD**

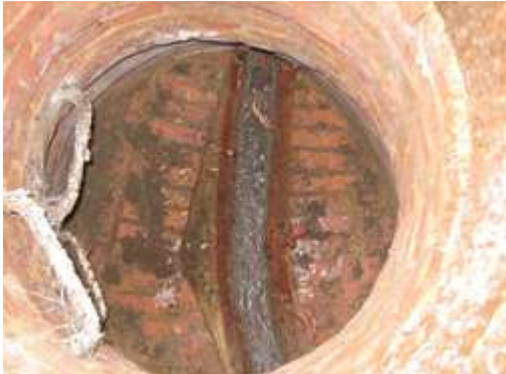
Top View

Evidence of surcharge - Bench debris.

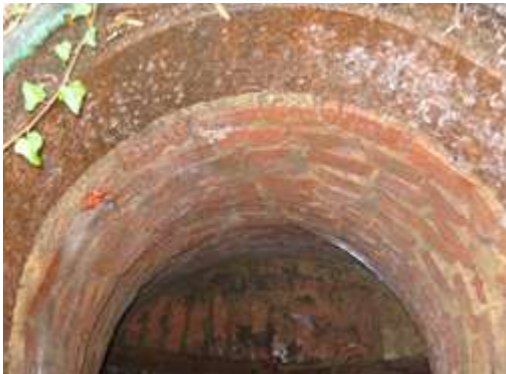
Defect

Adjustment, Corbel and Barrel infiltration.

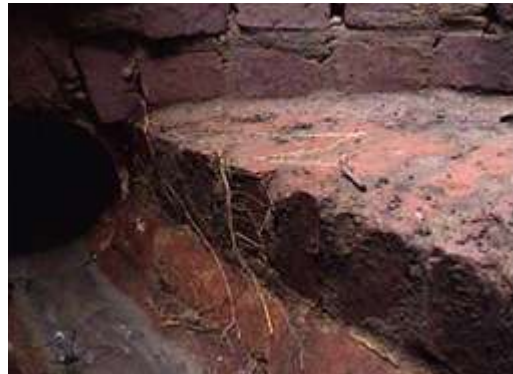
Defect

Barrel and Channel root intrusion.

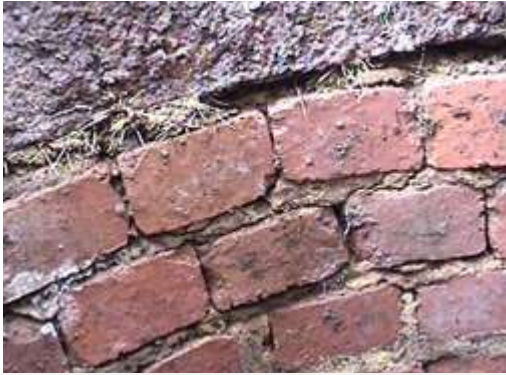
Defect

Adjustment deterioration, root intrusion and infiltration.

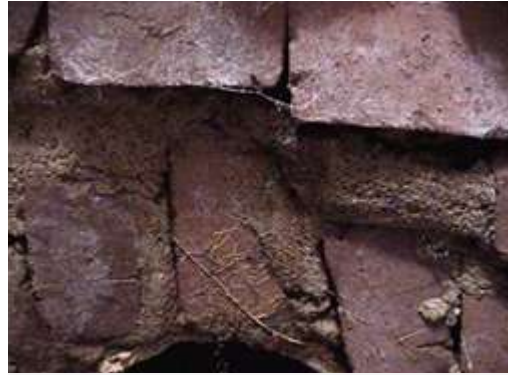
Defect

Barrel deterioration, root intrusion and infiltration.

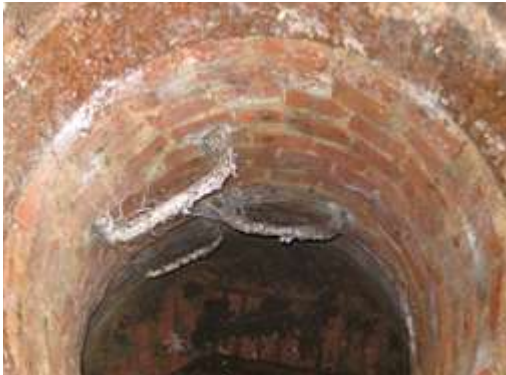
Defect

Adjustment, Corbel and Barrel infiltration - other side.

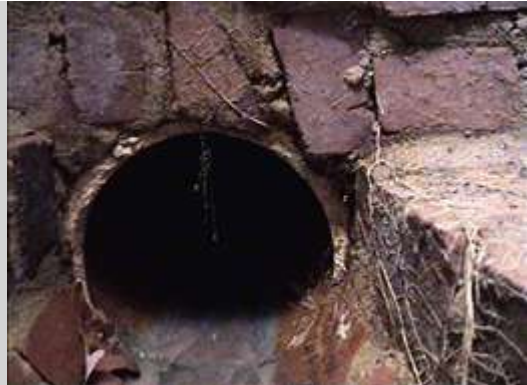
### 8 in. Circular Gravity Sewer Pipe Out @ 12 O'Clock

Infiltration: **Evidence** Pipe Seal Cond: **Roots**

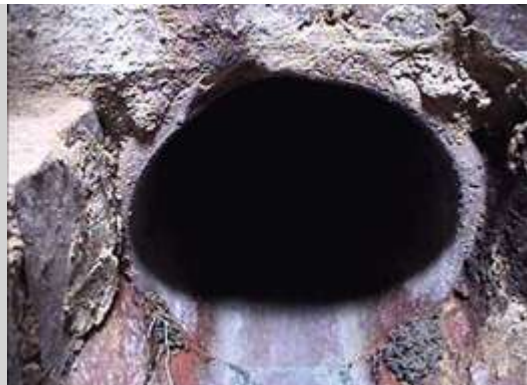
### 8 in. Circular Gravity Sewer Pipe In @ 6 O'Clock

Infiltration: **Evidence** Pipe Seal Cond: **Roots**
